Manhole Inspection Summary

Manhole # S23E1_004MH

Insp Date: **7/9/08 1:32 PM**

Location Address: **Behind 2520 Hollins Ferry Rd.**

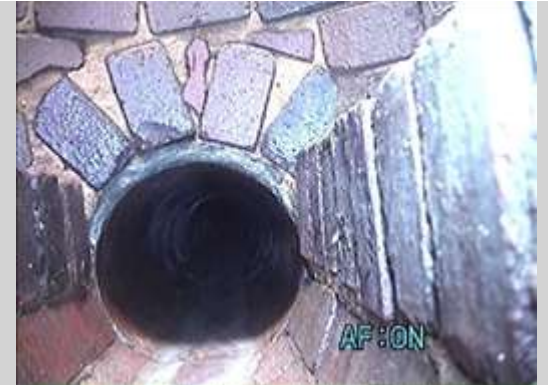
12 O'Clock Outflow

8 in. Circular Gravity Sewer
Pipe Out @ 12 O'Clock

Pipe Height: **8.4** (in.) Rod and Bar (Angled)
Pipe Material: **Clay** ☐ Pipe Lined
Invert Depth: **7.72** (ft.) Flow Characteristics: **Slow**
Deposits: ☒ None ☐ Mud ☐ Sludge ☐ Debris ☐ Grease
Silt Depth: **0** (in.) Deposits Extent:
Infiltration: **None** Pipe Seal Cond: **Sound**

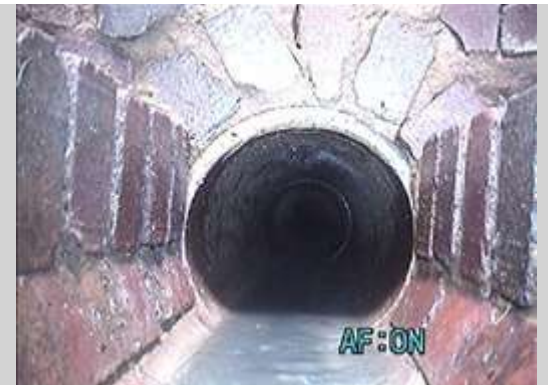
6 O'Clock Inflow

8 in. Circular Gravity Sewer
Pipe In @ 6 O'Clock

Pipe Height: **8.4** (in.) Rod and Bar (Angled)
Pipe Material: **Clay** ☐ Pipe Lined
Invert Depth: **7.64** (ft.) Flow Characteristics: **Slow**
Deposits: ☒ None ☐ Mud ☐ Sludge ☐ Debris ☐ Grease
Silt Depth: **0** (in.) Deposits Extent:
Infiltration: **None** Pipe Seal Cond: **Sound**
